Storm Water Construction General Permit Inspection Report

Central Valley Regional Water Quality Control Board

Insp. Date & Time:	5/04/09	Inspected By:	R Muhl
WDID #	5S39C351737	Site County:	San Joaquin
Owner Name:	East Bay Mud Municipal District		
Site Name:	SJ Louis Construction Inc		
Site Address:	Folsom S Canal Connection Project

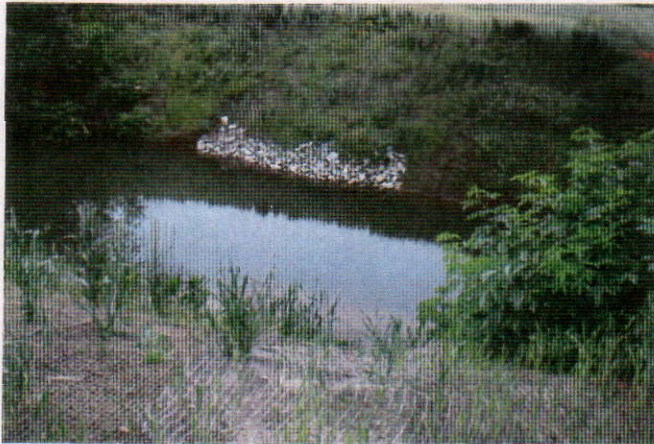
Figure 1: Overview of the Dry Creek Crossing

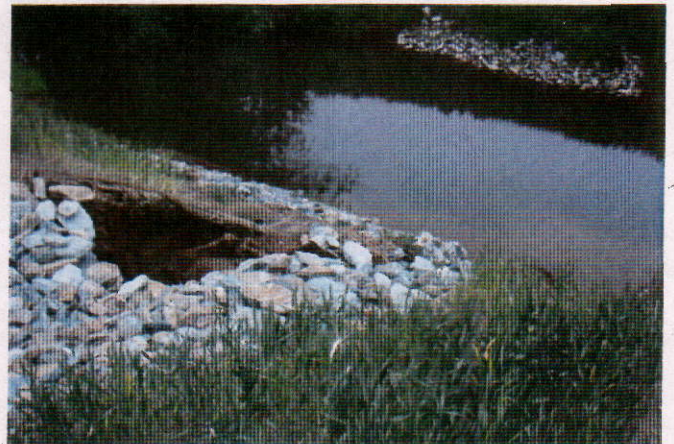
Figure 2: View of one portion of the area that was impacted by the discharge

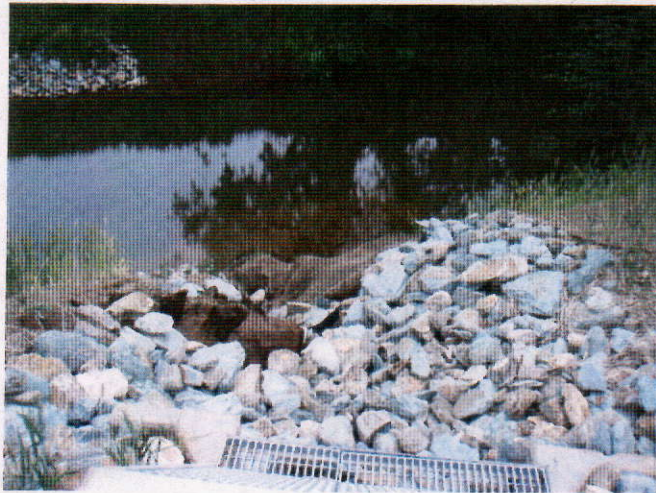
Figure 3: Another view of the discharge area

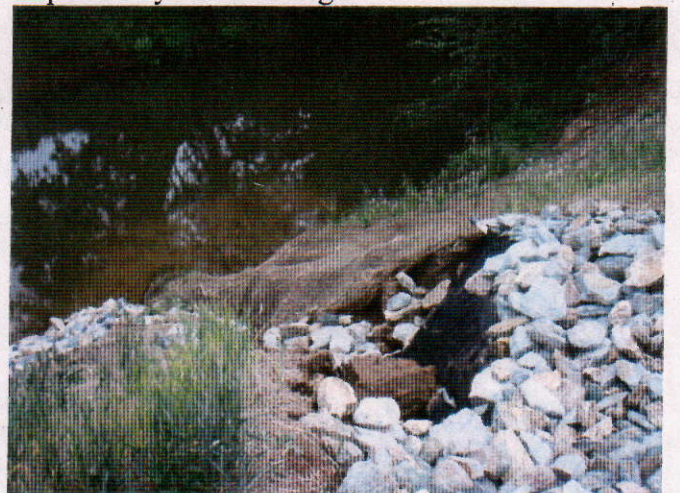
Figure 4: View of one portion of the area that was impacted by the discharge

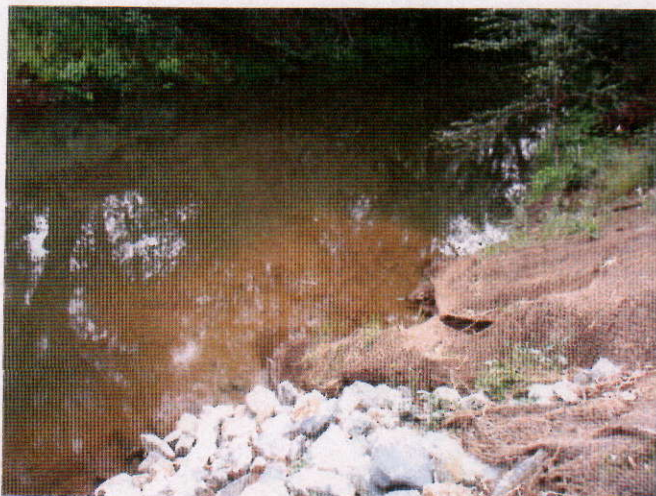
Figure 5: Sediment deposited in the creek as a result of the discharge

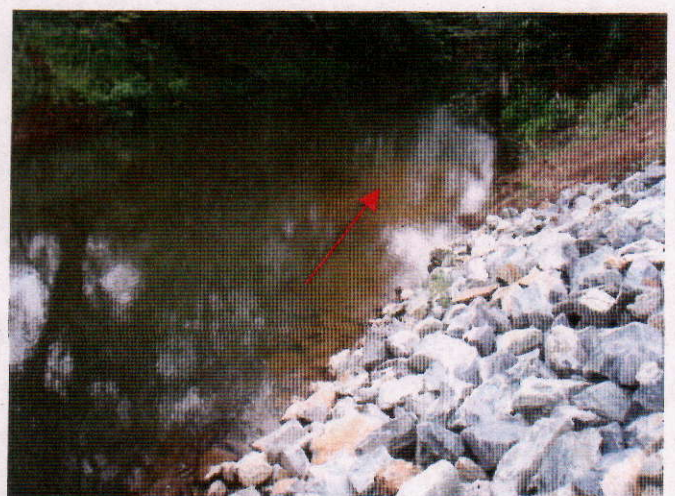
Figure 6: View of the sediment that is migrating downstream as a result of the discharge

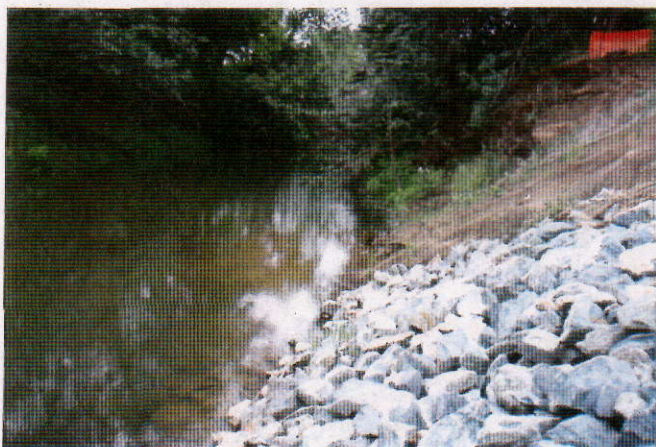
Figure 7: Another view of the discharge area

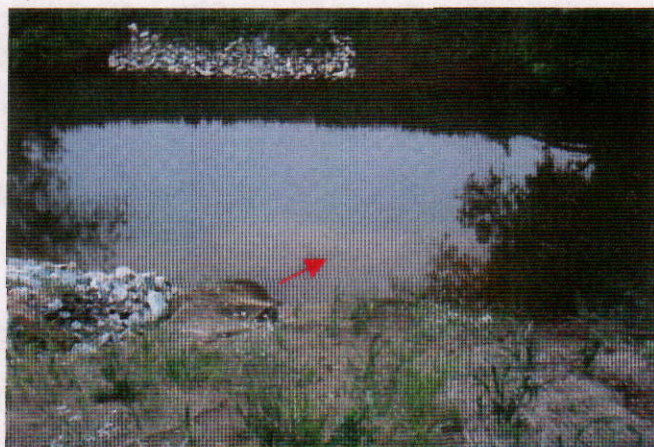
Figure 8: Another view of sediment in the creek

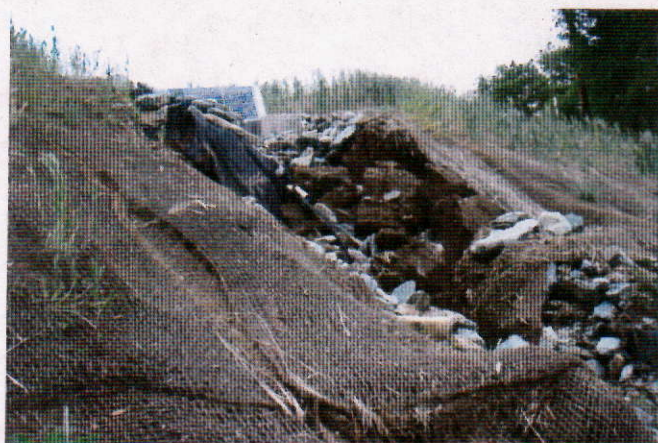
Figure 9: A portion of the washed out area Note: much of the surrounding area under the blanket was also washed away

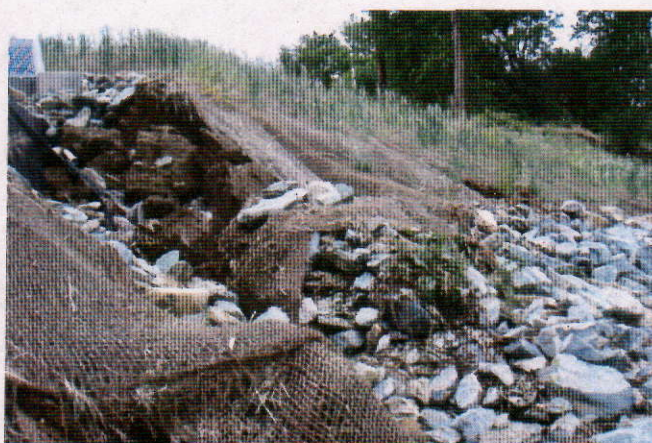
Figure 10: Another view of the area that washed out as a result of the discharge

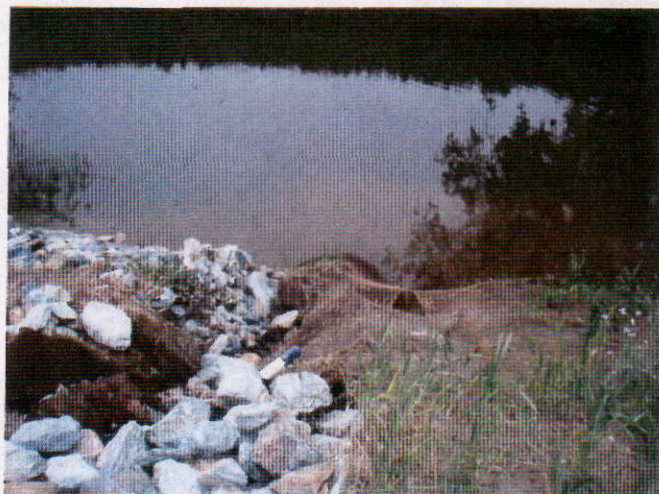
Figure 11: Another view of one portion of the impacted area

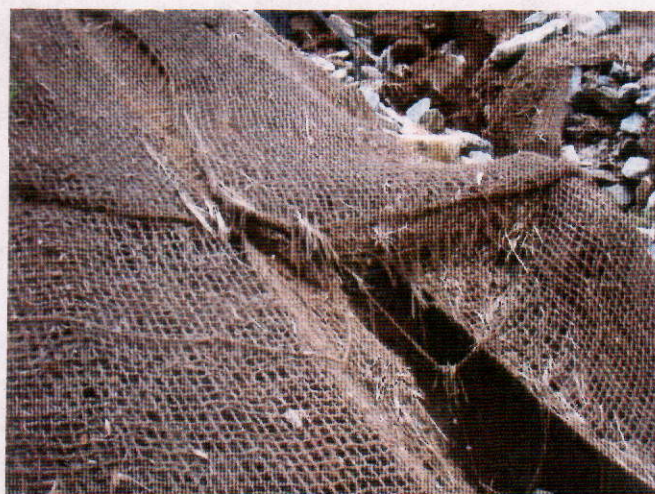
Figure 12: Close up of one of the areas where the discharge washed out the sediment from underneath the erosion control blanket

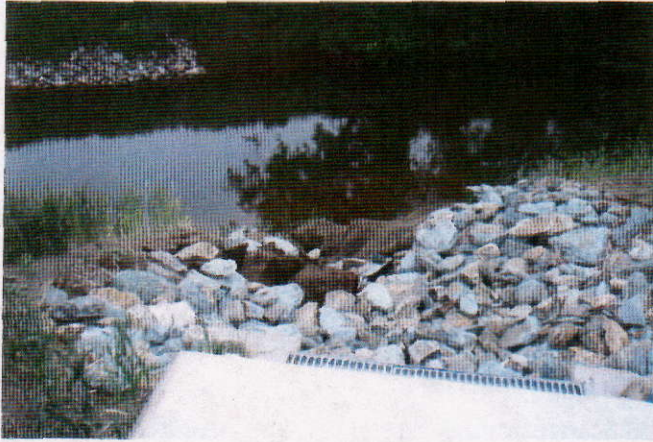
Figure 13: Another view of the discharge area

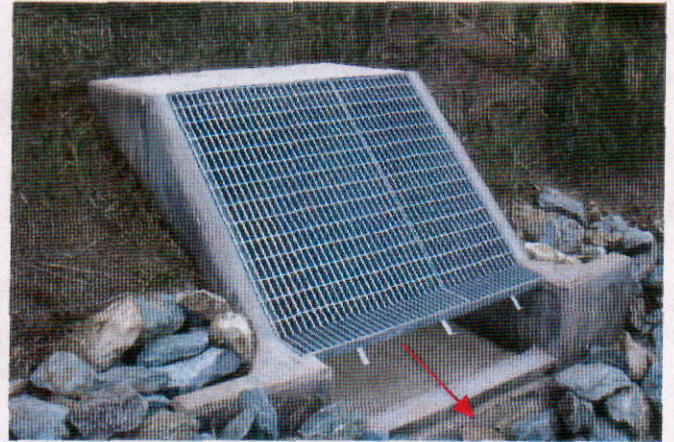
During the site inspection, staff investigated a significant discharge into Dry Creek. According to the preliminary reports an SJ Lewis employee opened a valve on a pipe that discharged water into Dry Creek. The discharge eroded a large portion of the bank adjacent to Dry Creek and deposited a great deal of sediment in the creek channel. This sediment appears to be migrating down the creek channel due to high flow conditions in the creek. At the time of the inspection the volume of water discharged was unknown however it was likely a large volume of water based on the amount of damage to the bank above the creek (see inspection photographs). Staff asked EBMUD to submit a report explaining what occurred, the volume of water discharged and an estimate of the estimated volume of sediment deposited in the channel. This report is due 11 May 2009 at 5:00 PM.

Figure 14: Source of the discharge

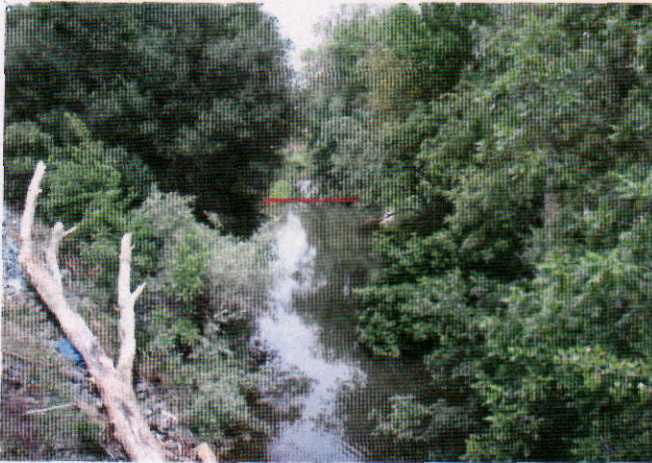
Figure 15: View of Dry Creek looking upstream at the discharge area.

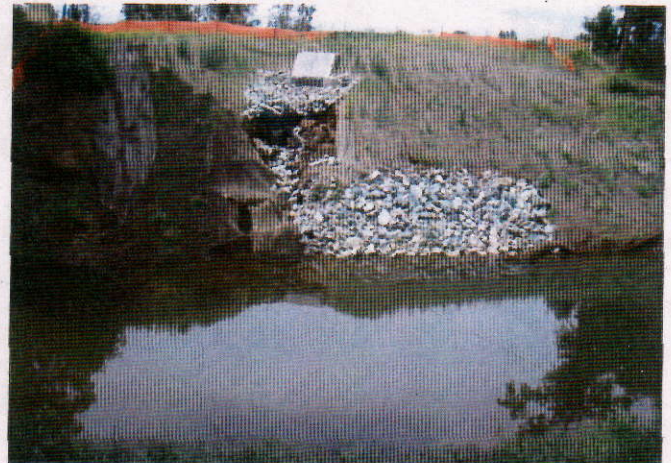
Figure 16: View of the discharge area from the other side of Dry Creek

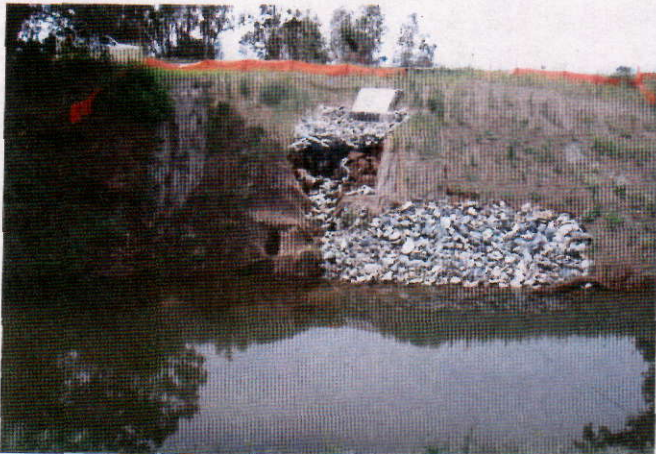
Figure 17: View of the discharge area from the other side of Dry Creek

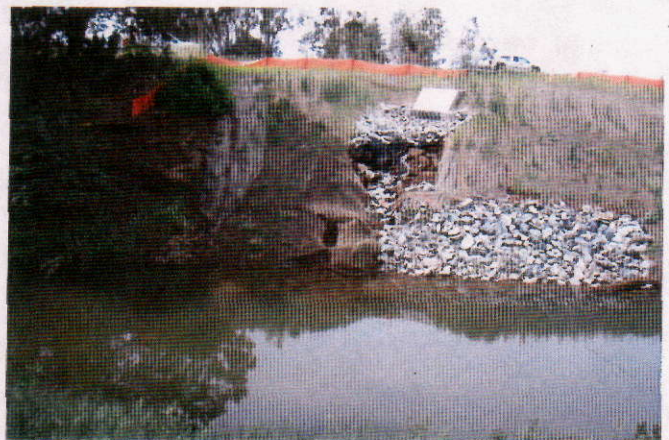
Figure 18: View of the discharge area from the other side of Dry Creek
